RCRA PRIORITIZATION SYSTEM SCORING SUMMARY

DURA-BOND STEEL CORPORATION

EPA SITE NUMBER: FLD-982-168-072

JACKSONVILLE, FL

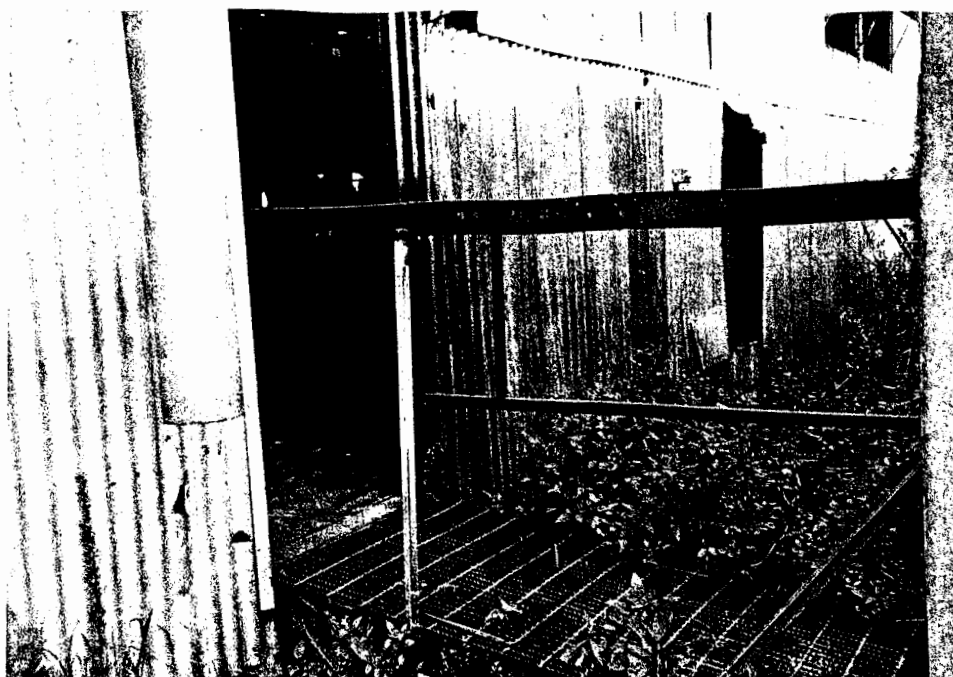
1.1 Location of the Area Adjacent to West Side of Main Facility Building (SWMU 1), facing south. The unit is located where the vegetation is growing. (1-20)

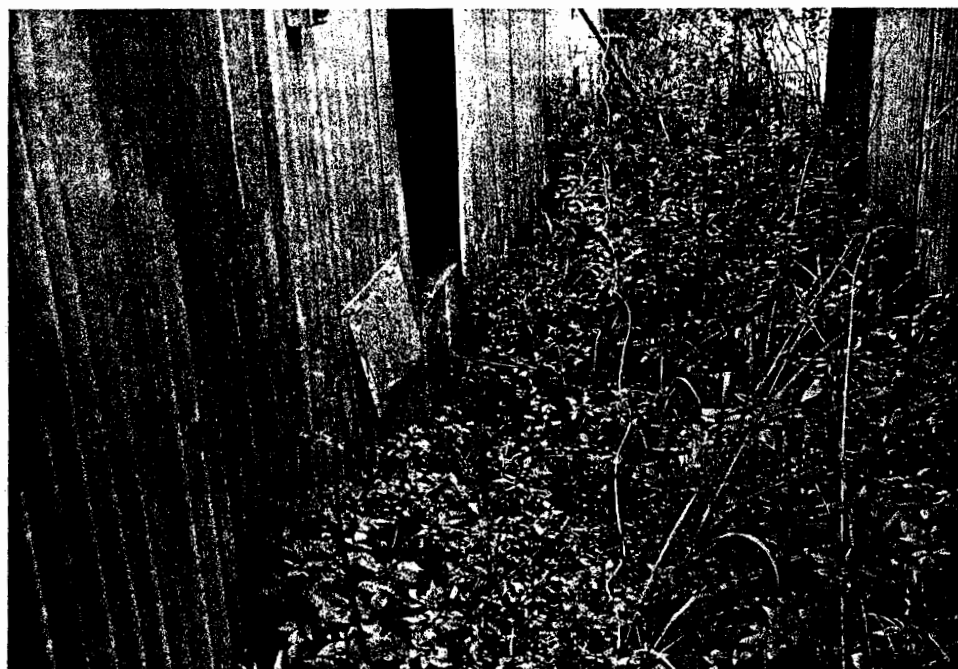
1.2 Close-up view of the Area Adjacent to West Side of Main Facility Building (SWMU 1), facing south. Note the area is grown over with weeds. The door leads into the main facility building. Reportedly, the paint guns were directed out of this door for cleaning. (1-21)

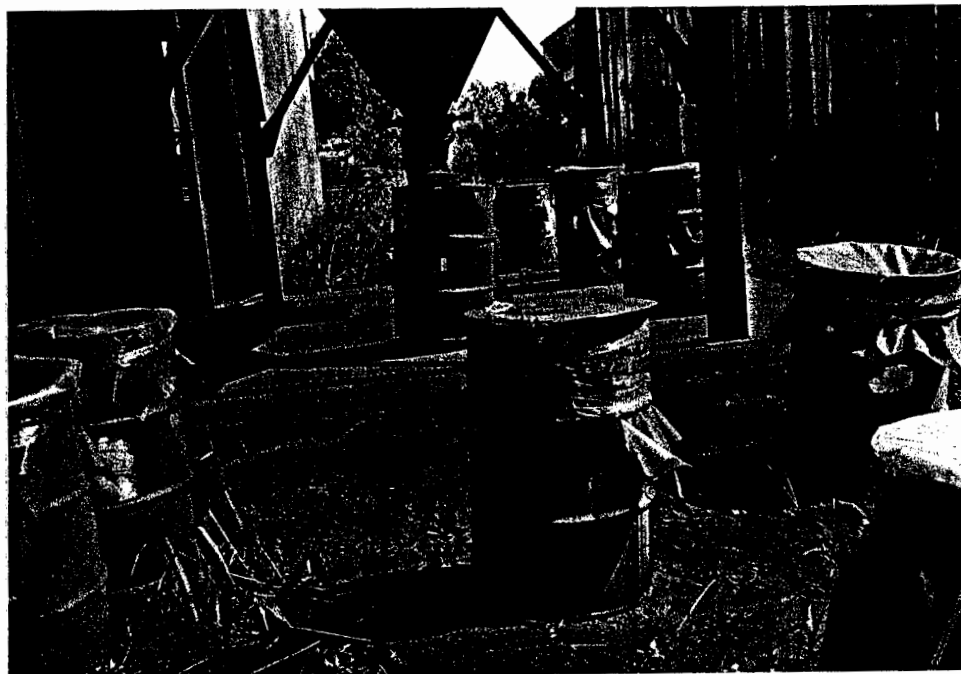
Residual dust from the Wheelabrator® machine was mechanically removed from the machine through a baghouse which is part of the Wheelabrator® Dust Collector (SWMU 5). This unit is located adjacent to the outside eastern wall of the building. According to Mr. Norris, the dust from the dust collector emission control system contained worn shot, grit, and millscale, which was collected in 55-gallon drums (References 20, 104). This residual material was a dark gray colored dust that also dispersed to the concrete pad beneath the baghouse and the surrounding ground. The steel shot/grit and millscale residue was sold to Chatham Steel, the facility which conducts operations immediately west of the Dura-Bond property, to be recycled or was shipped offsite for disposal at a sanitary landfill (References 25, 27, 100, 104).

5.2 Closeup view of the Wheelabrator Dust Collector (SWMU 5) downspout, facing north. The drums contain shot blast dust. Note the soil surrounding the downspout is covered with shot blast dust. (1-6)

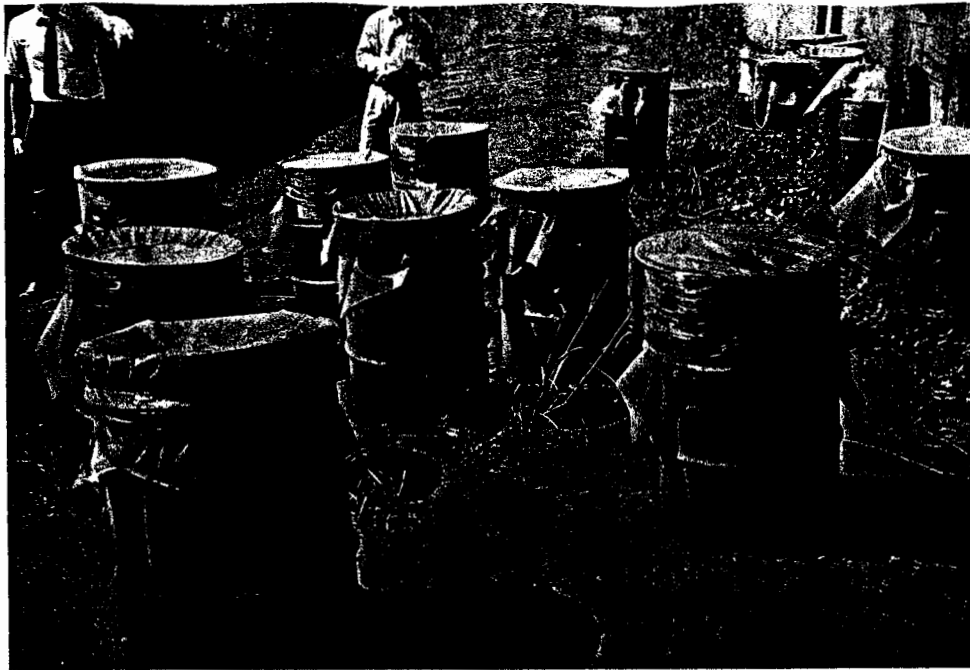
5.3 View of the drums containing shot blast dust from the Wheelabrator Dust Collector (SWMU 5), facing south. Note that the shot blast dust is on the soil surrounding the drums. (1-7)

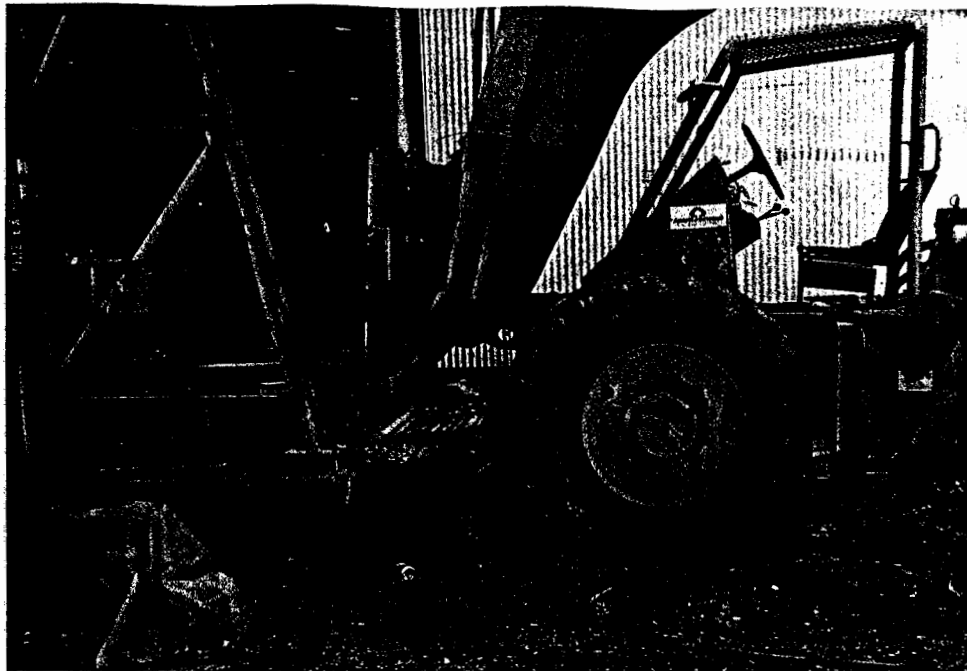
9.1 Facing south towards the Historical Outside Storage Area (SWMU 9). In the past, drums were located where the fork lift is parked. (1-12)

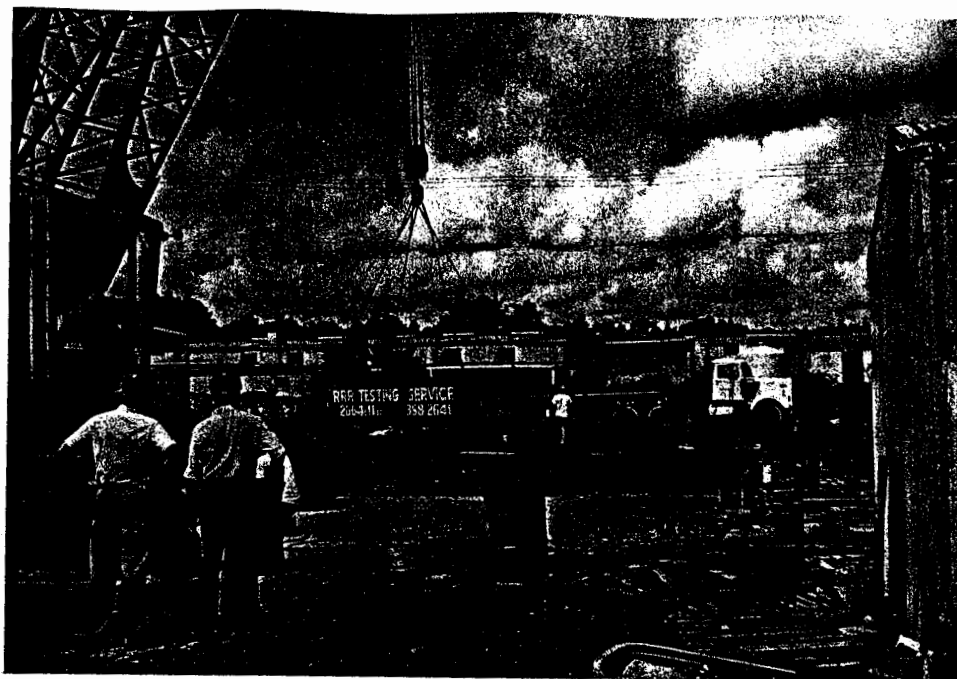
9.2 Photograph showing the former condition of the Historical Outside Storage Area (SWMU 9) as well as the current condition of the area (in the background where the forklift is located), facing south. (1-14)

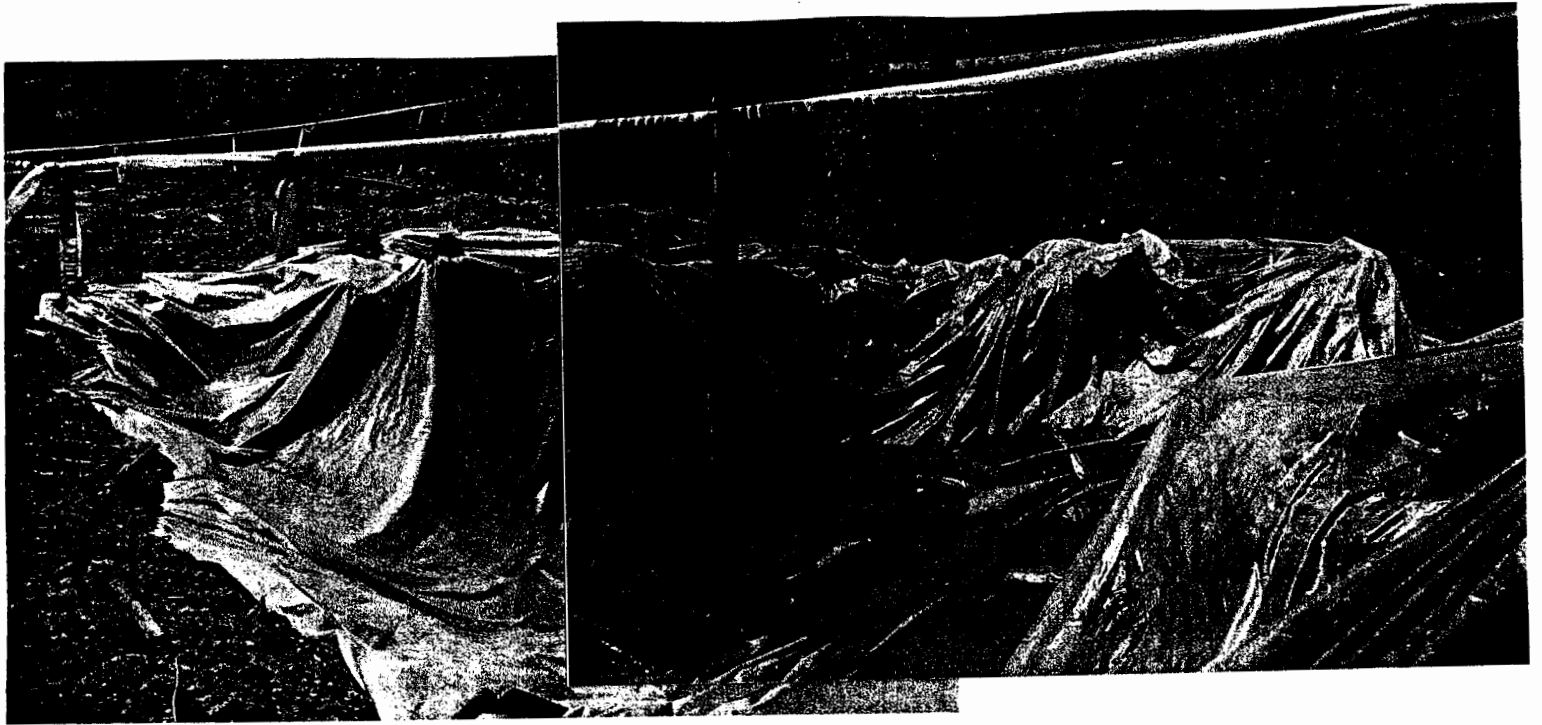
- 12.1 Overview of the Paint Can Excavation Drum Storage Area (SWMU 20), facing southwest. Note that most of the drums are positioned on wooden pallets. The drums contain visibly contaminated soil from the Paint Cans Excavation Area (SWMU 12). The Construction Debris/Soil Pile (SWMU 21) in the immediate background was created during construction activities for the new painting building. (1-33, 1-34)

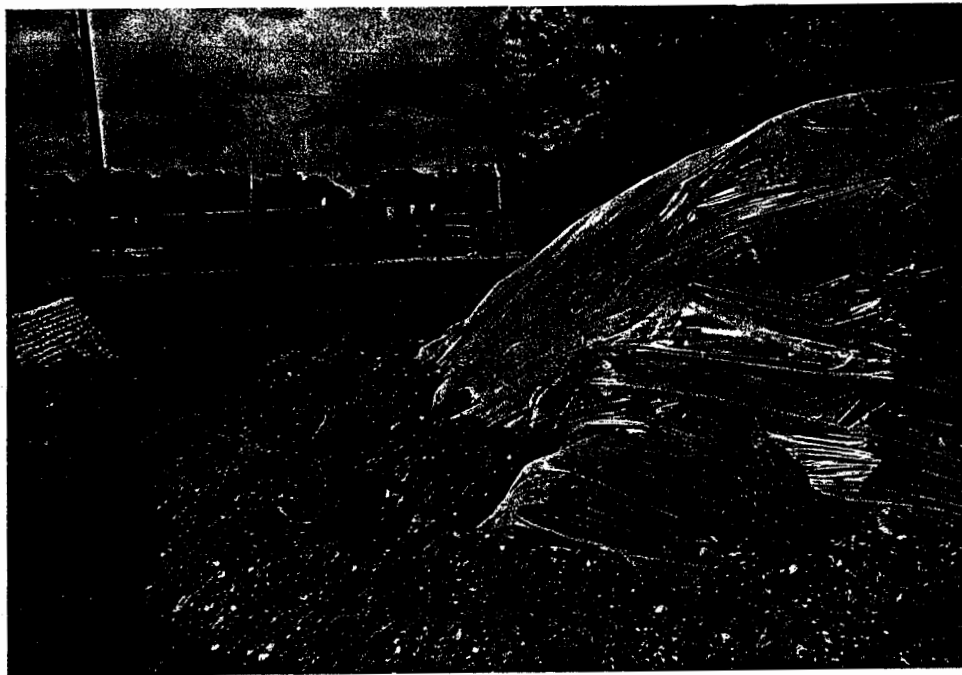
12.5 Overview of the Paint Cans Excavation Area (SWMU 12), facing northwest. Note the Highway Avenue drainage ditch is in the foreground. (2-22)

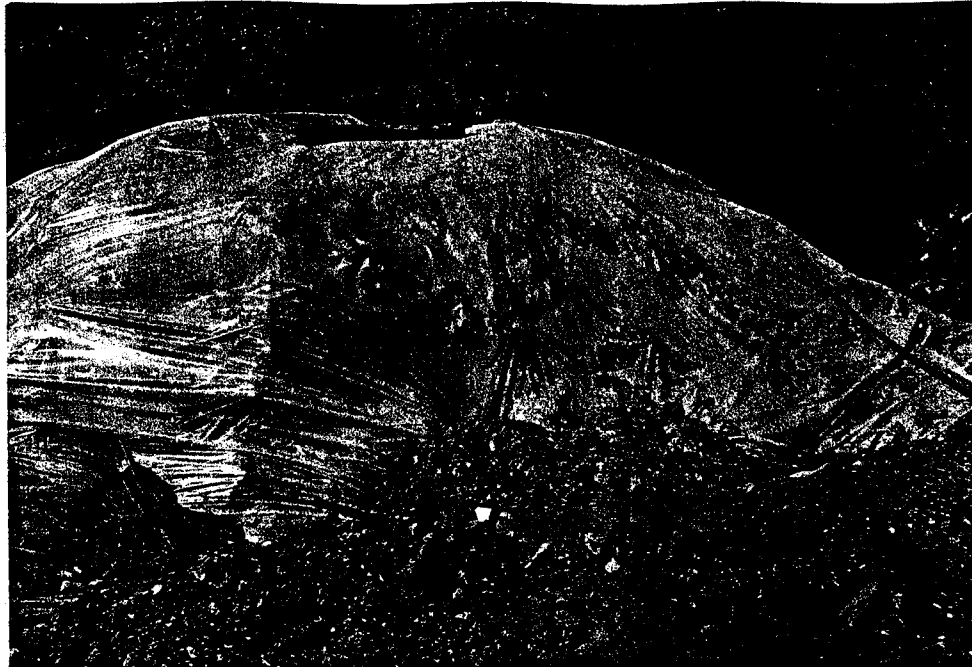
13.1 Facing south adjacent to the Covered Soil Pile (SWMU 13). Note the drainage ditch along Highway Avenue is in the background. Runoff collects in the bermed area and flows to the Highway Avenue drainage ditch. (2-1)

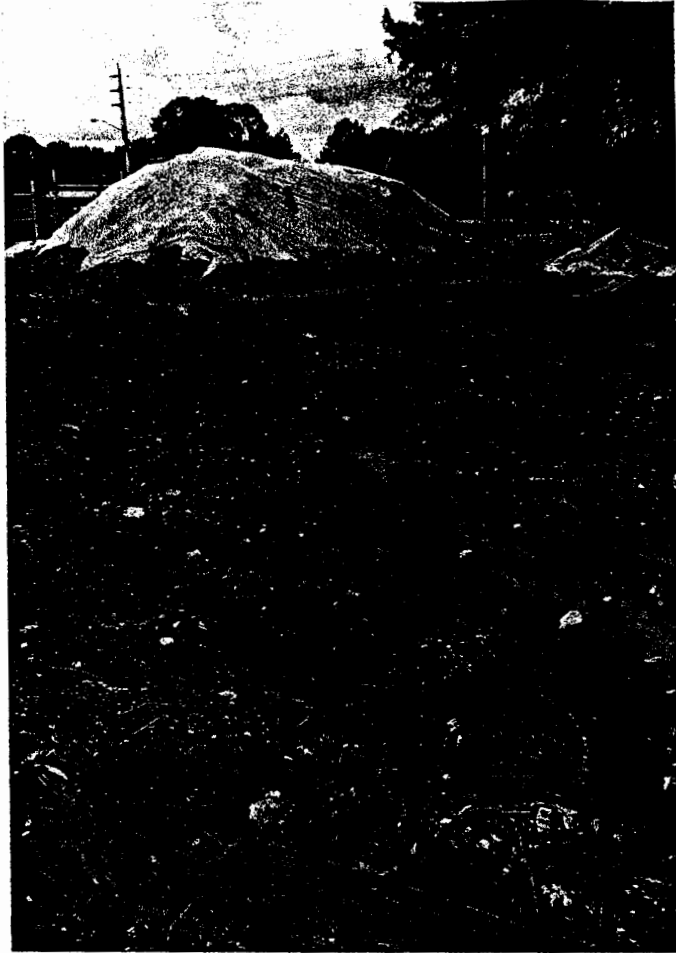
13.6

Overview of the Covered Soil Pile (SWMU 13) in the background, and the Storm Water System (SWMU 18) drain in the foreground, facing southeast. (3-12)

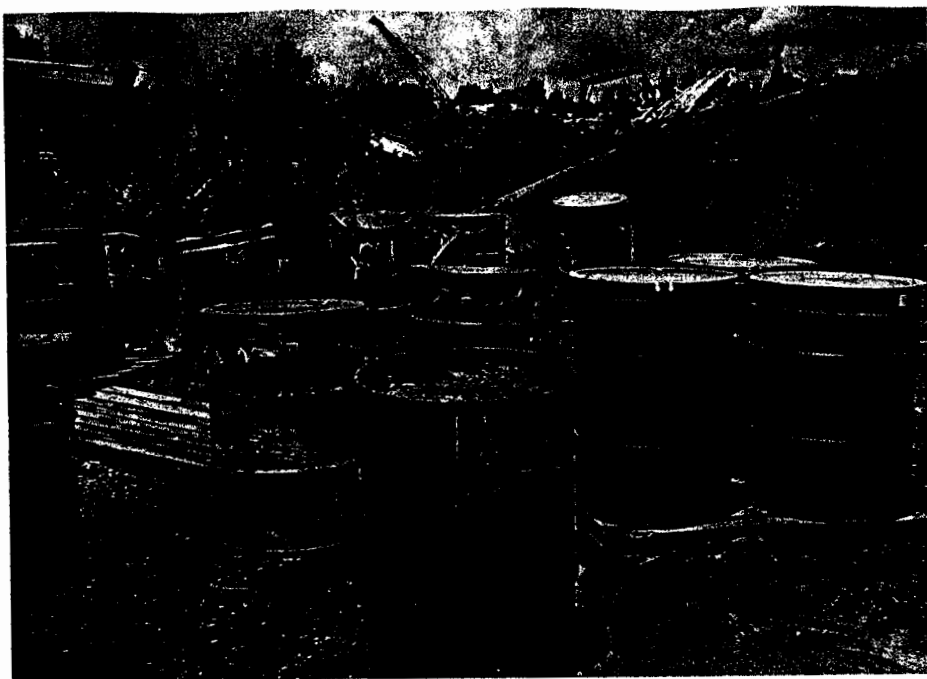
15.1 Shot Blast Dust Drum Storage Area (SWMU 15) surrounding the Sandblast Area (SWMU 16), facing west. Note the drums contain shot blast dust and one drum, labeled paint waste, actually was storing construction rubble. (2-29)

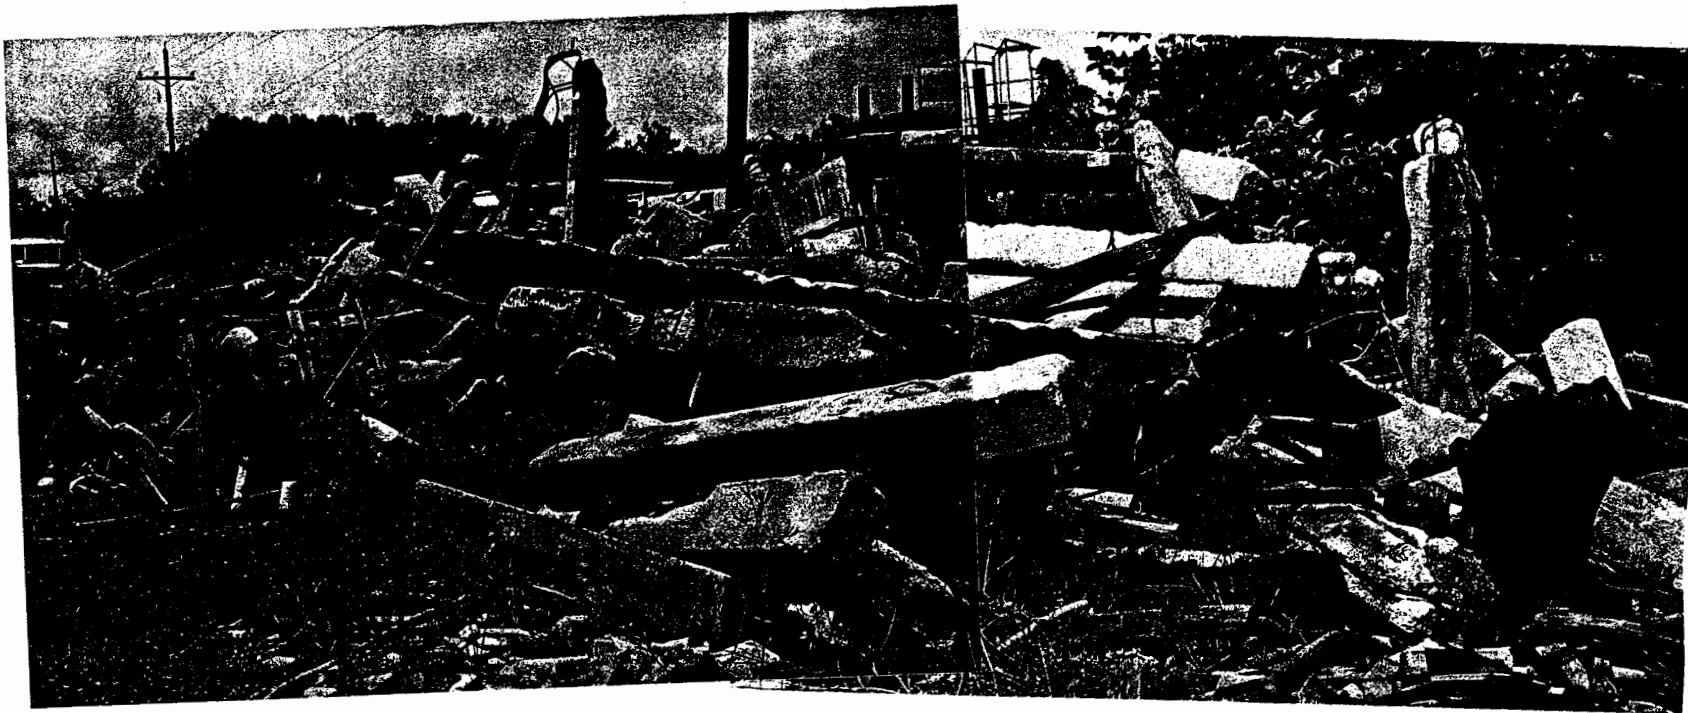
17.1 Facing west towards Chatham Scrap Metal. To the left foreground is the Construction Debris Pile (SWMU 17). Note there appears to be an old 55-gallon drum beneath the piece of concrete. (1-29)

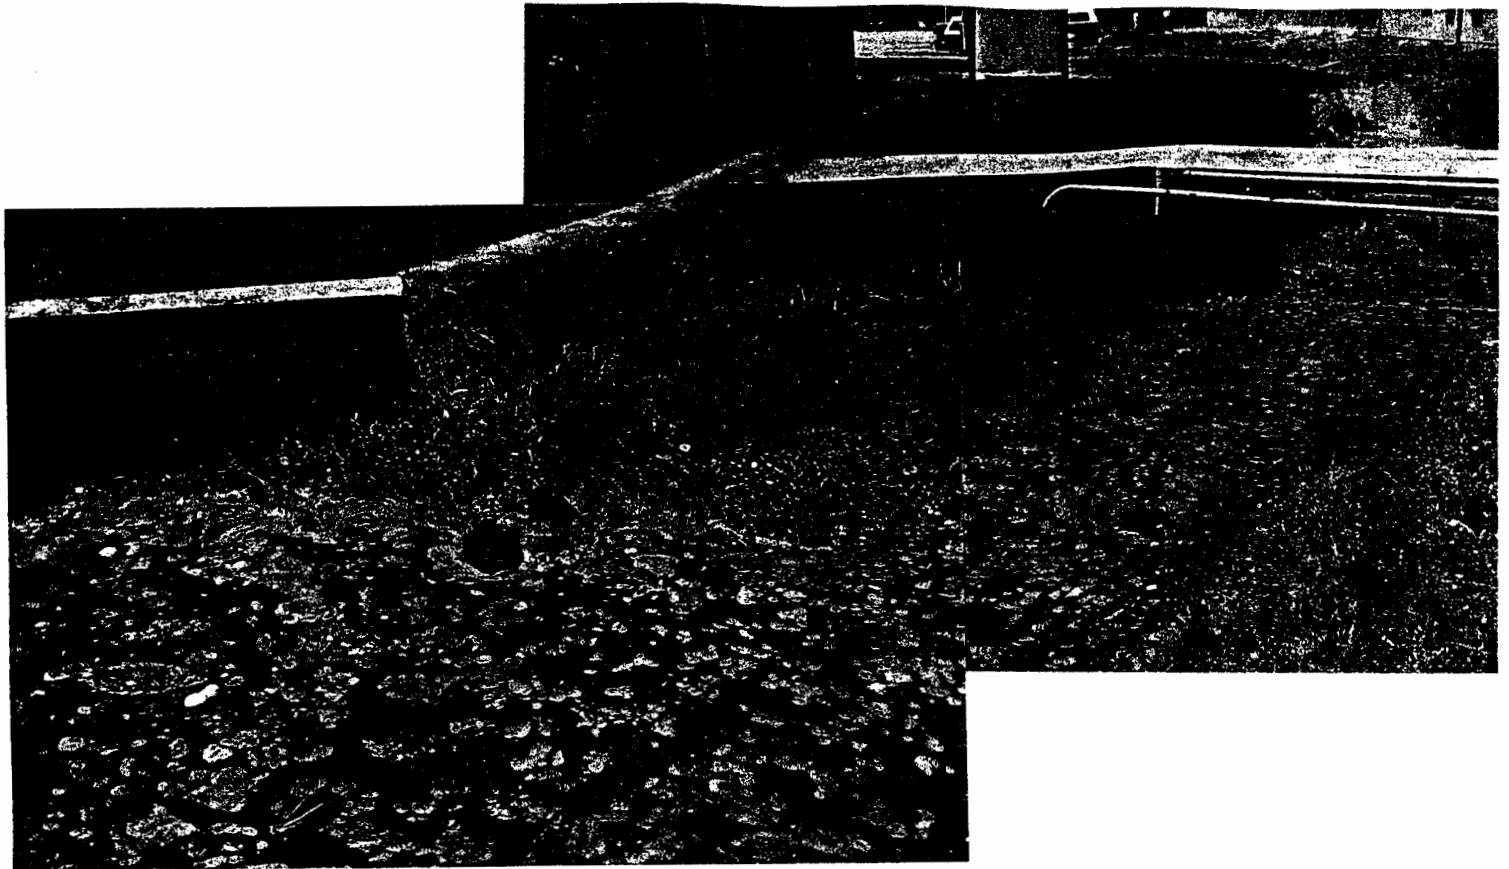
19.1

Panoramic view of Drainage Ditch (SWMU 19), from east to south. According to the facility, the dark coloration and scum on the surface is from the recent top soil application. The top soil application can be seen along the east side of the Drainage Ditch (SWMU 19). (2-12, 2-13)

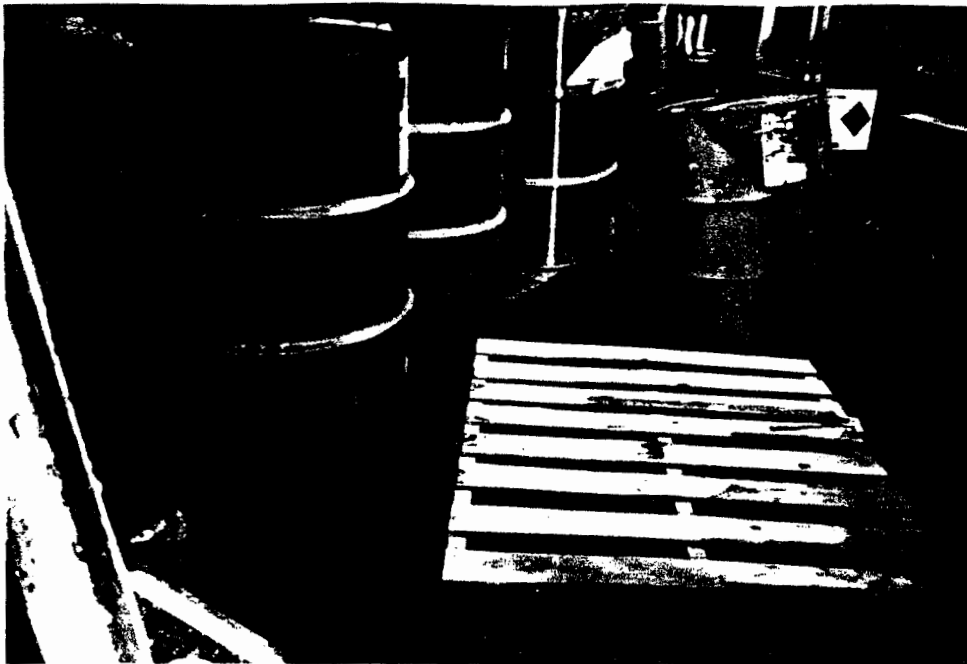
9.4 View of the Historical Outside Storage Area (SWMU 9), facing southwest. Note paint spillage on the concrete and the soil in the background.

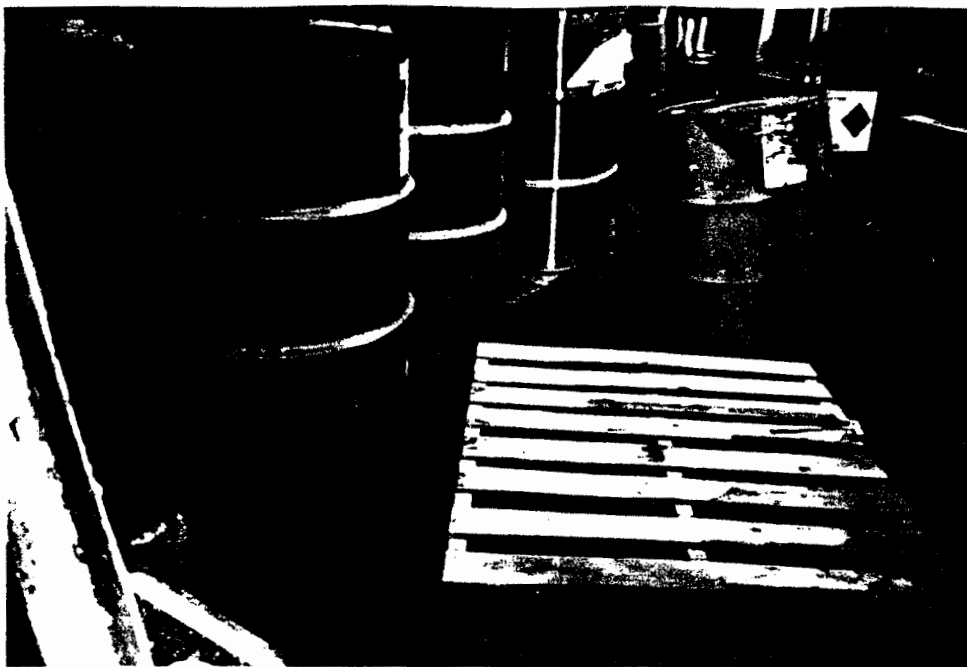
9.4 View of the Historical Outside Storage Area (SWMU 9), facing southwest. Note paint spillage on the concrete and the soil in the background.

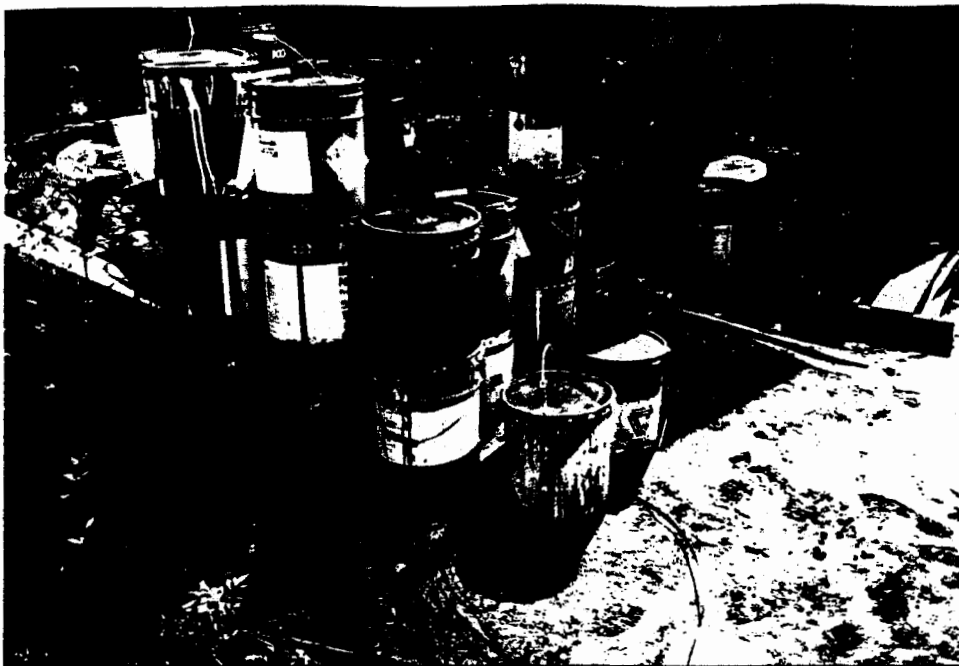
10.2 View of the area outside of the Blue Shed (SWMU 10), facing an unknown direction. Note the paint cans are covered and most are resting on wooden pallets.
